TILSTANDSRAPPORT

Registreringsnummer	EH61672	Stelnummer	YSMVSEFE6PL141491		
Mærke	Polestar	Model	2	Version	Standard range single motor 69 kWh 5-dr 2WD
Karrosseritype	Sedan	Farve	Blå	Reg. dato	23-02-2023
Drivkraft	El	Drivlinje	Front wheel drive	Geartype	Automatisk
KM. stand	47669	Antal nøgler	2	Kontraktnummer	5183360
Afleveringsdato	16-03-2026

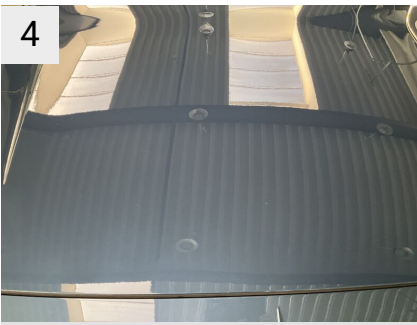
4

Sted	Motorhjem
Del	Hjem
Type	Stenslag flere

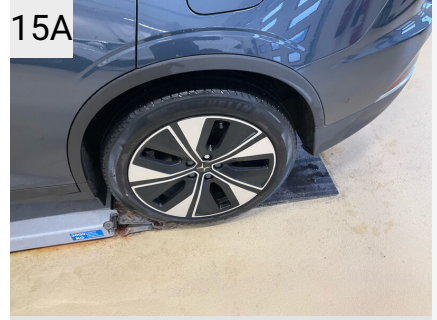
15A

Sted Fælge
Del Fælg Venstre, Bag
Type Ridset

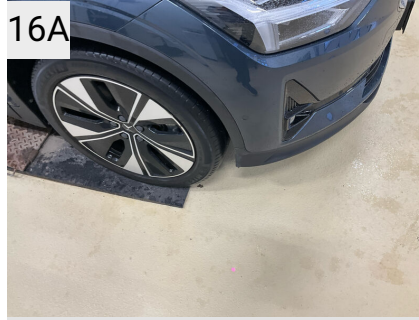
16A

Sted Front
Del
Type Rids

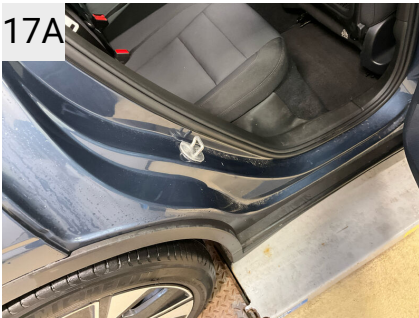
17A

Sted H. panel
Del Indstigning Højre Bag
Type Rids

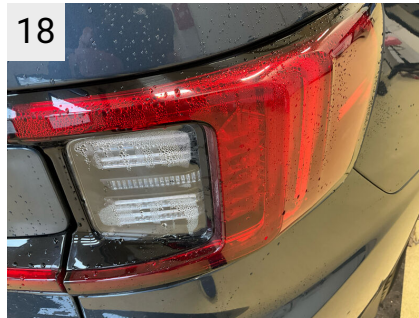
18

Sted Bagklap
Del Lygte, Højre
Type Utæt

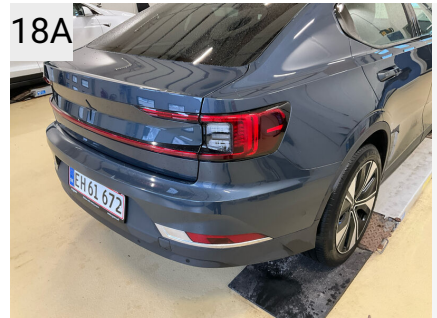
18A

Sted Bagklap
Del Lygte, Højre
Type Utæt
